Removal and Restoration Agreement for Residential Removals Libby, Montana

Address of Removal: 1325 Airstrip Rd

Type of Remediation: Vermiculite-containing insulation removal from attic and exterior removal

Exterior Inspection Checklist (EIC)

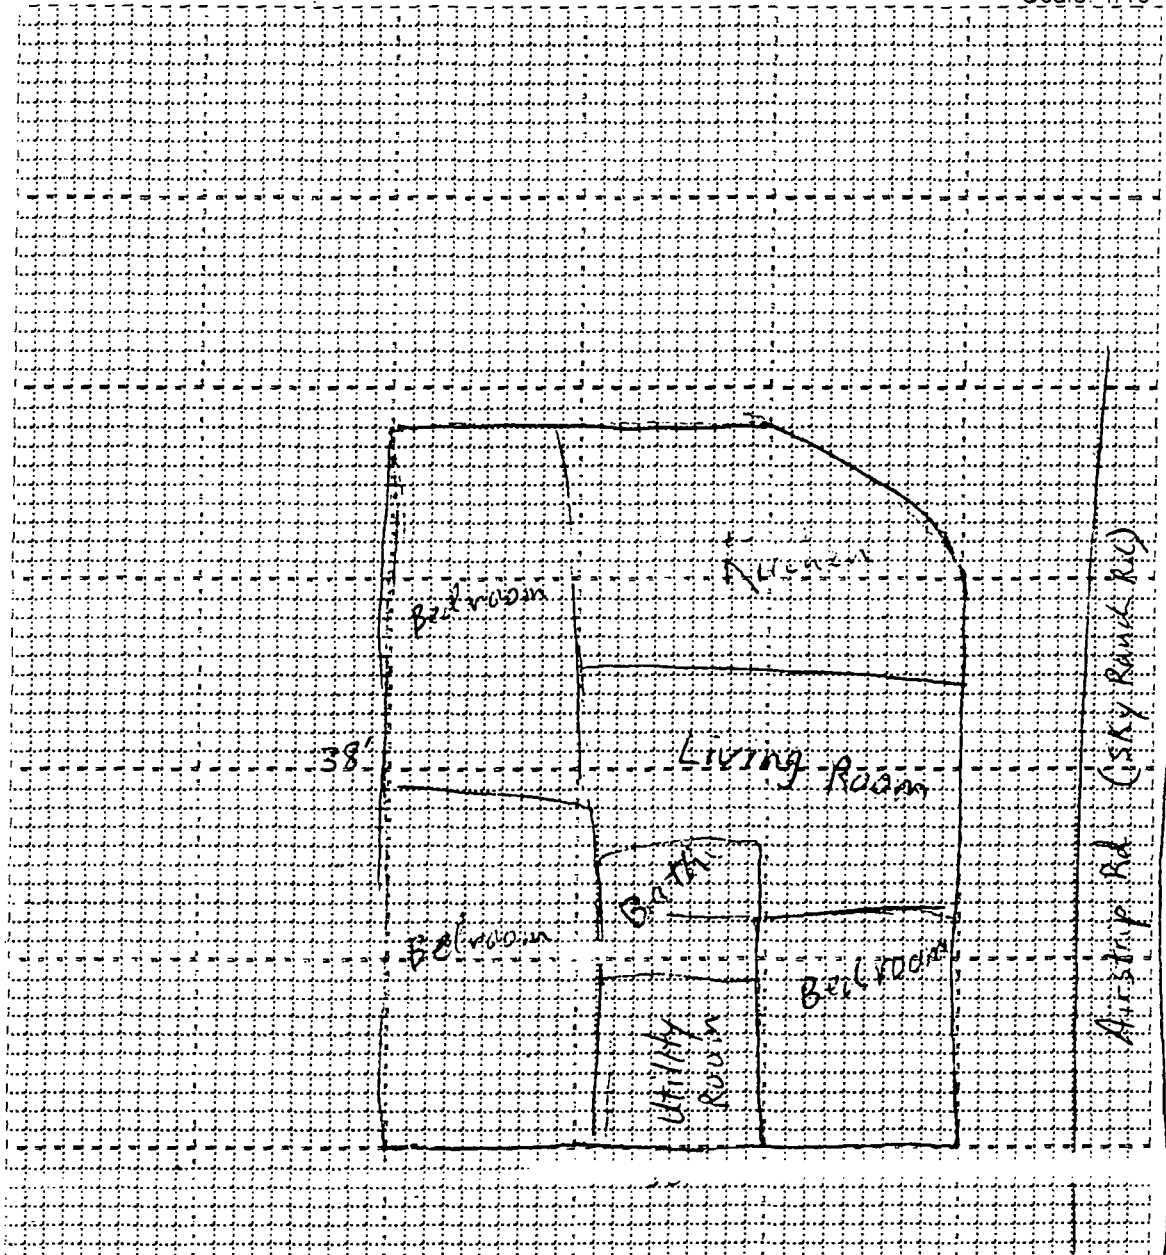
Approx. 1100 ft²

Note: Unable to determine thickness of vermiculite in house.

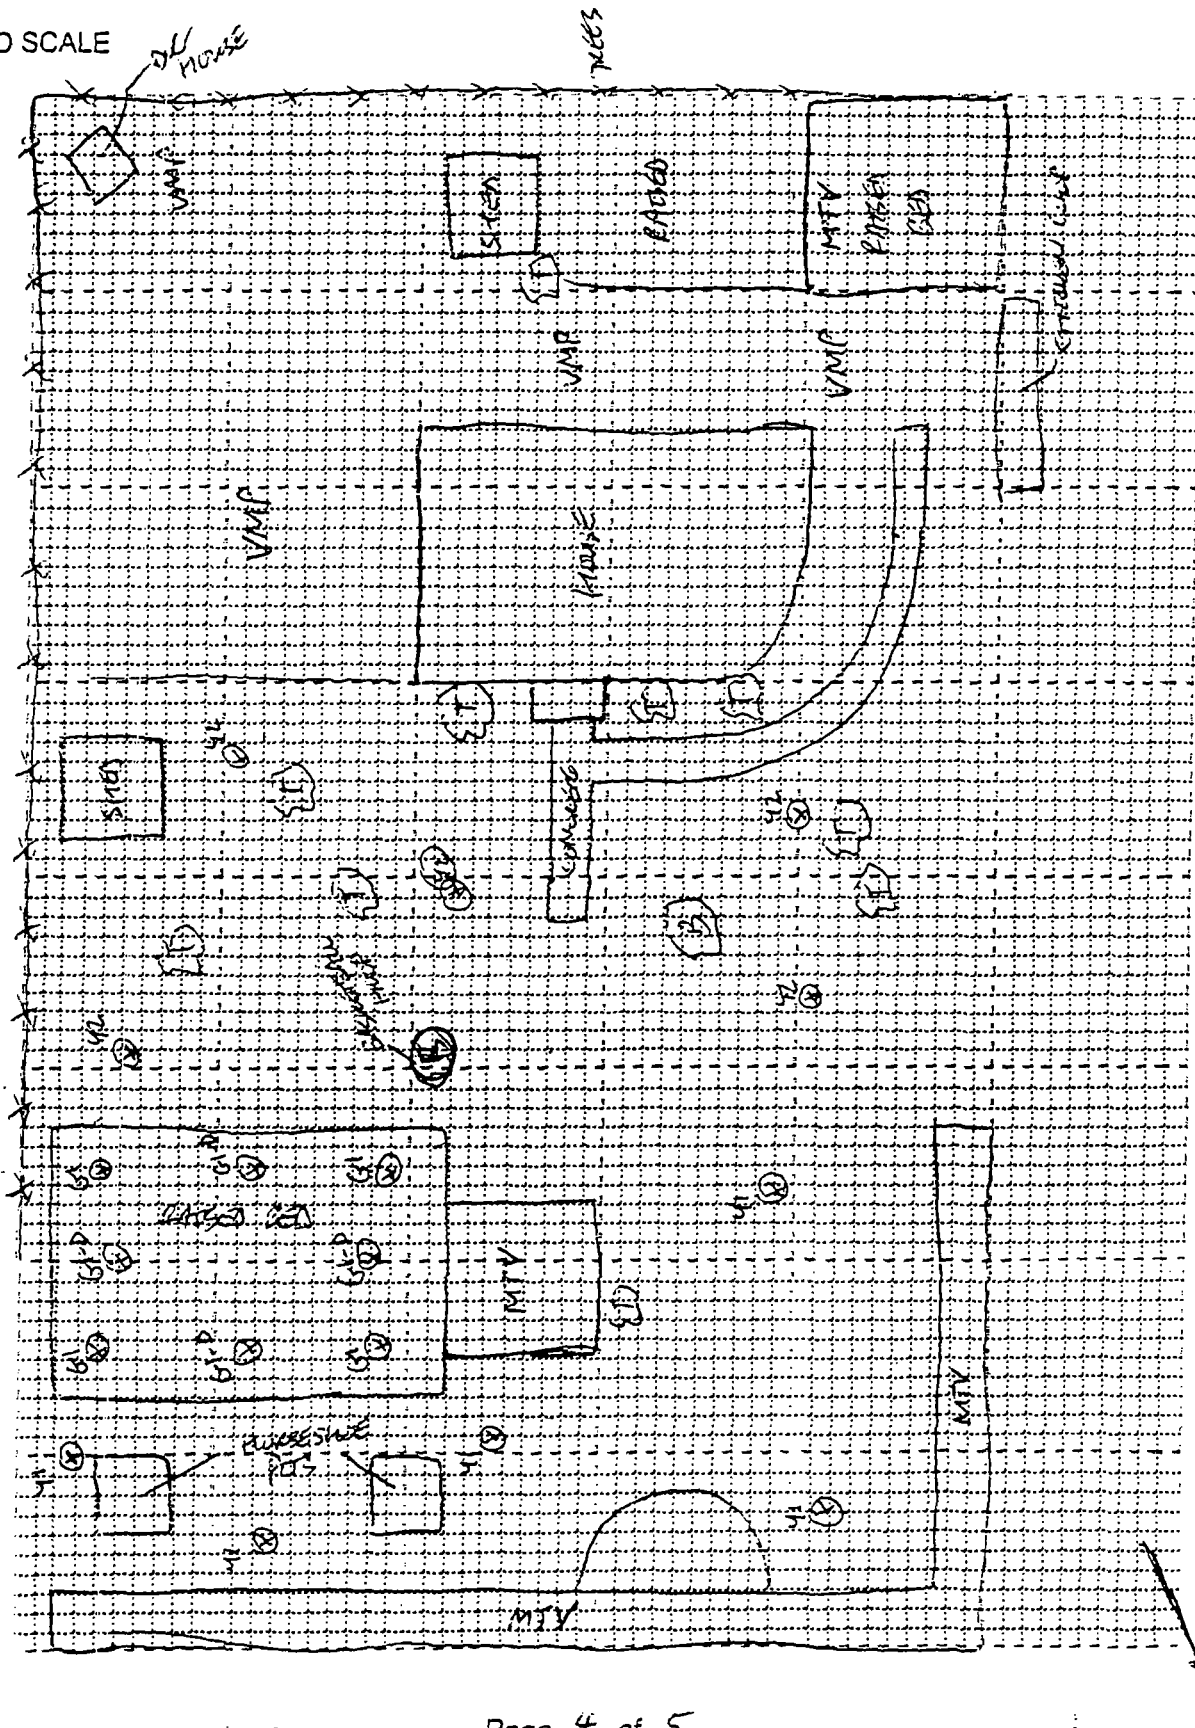
< vermiculite observed in several flowerbeds
and Back and Side yards. Tailing material
also in flower beds. LU Also visible at entrance
to Crawl Space. House has no electric & is
unliveable. Mold smell in house. LUAI in
attic & vermiculite in Plaster.

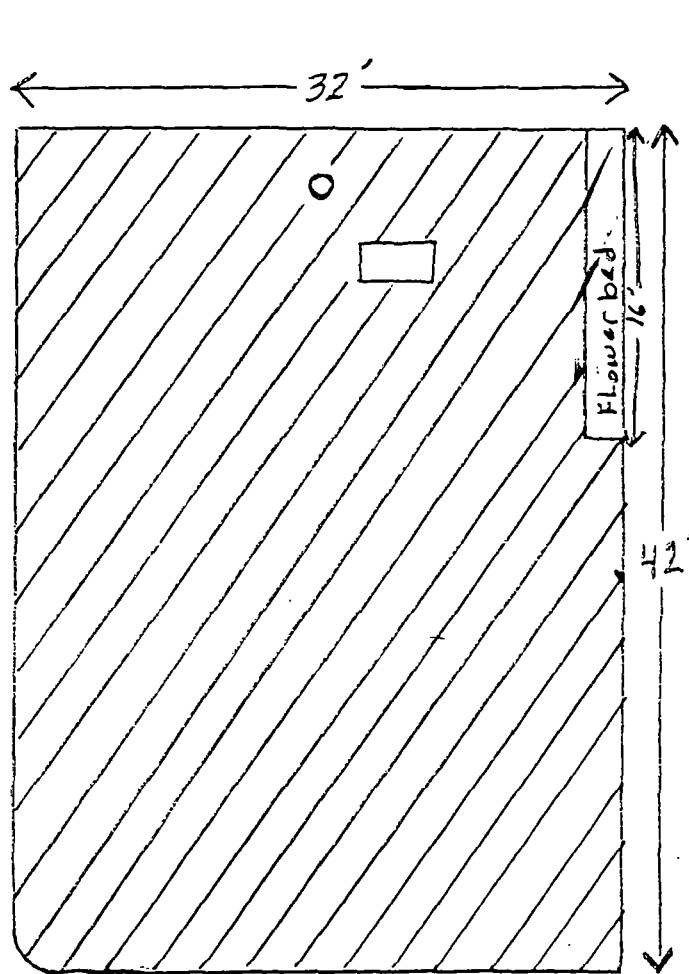
1325 Airstrip Rd.

* NO ACCESS to AHIC,
(Flat Roof)

Note: House in very
poor condition

VCI - in walls, ceiling,
Crawl Space, Floor.
